# RILEM TC CCC WG5

Effects of carbonation on corrosion of  
concrete with SCMs

# Field Survey on Re-bar Corrosion of Carbonated Existing Concrete Buildings in Japan

Kei-ichi Imamoto, Tokyo University of Science, Japan

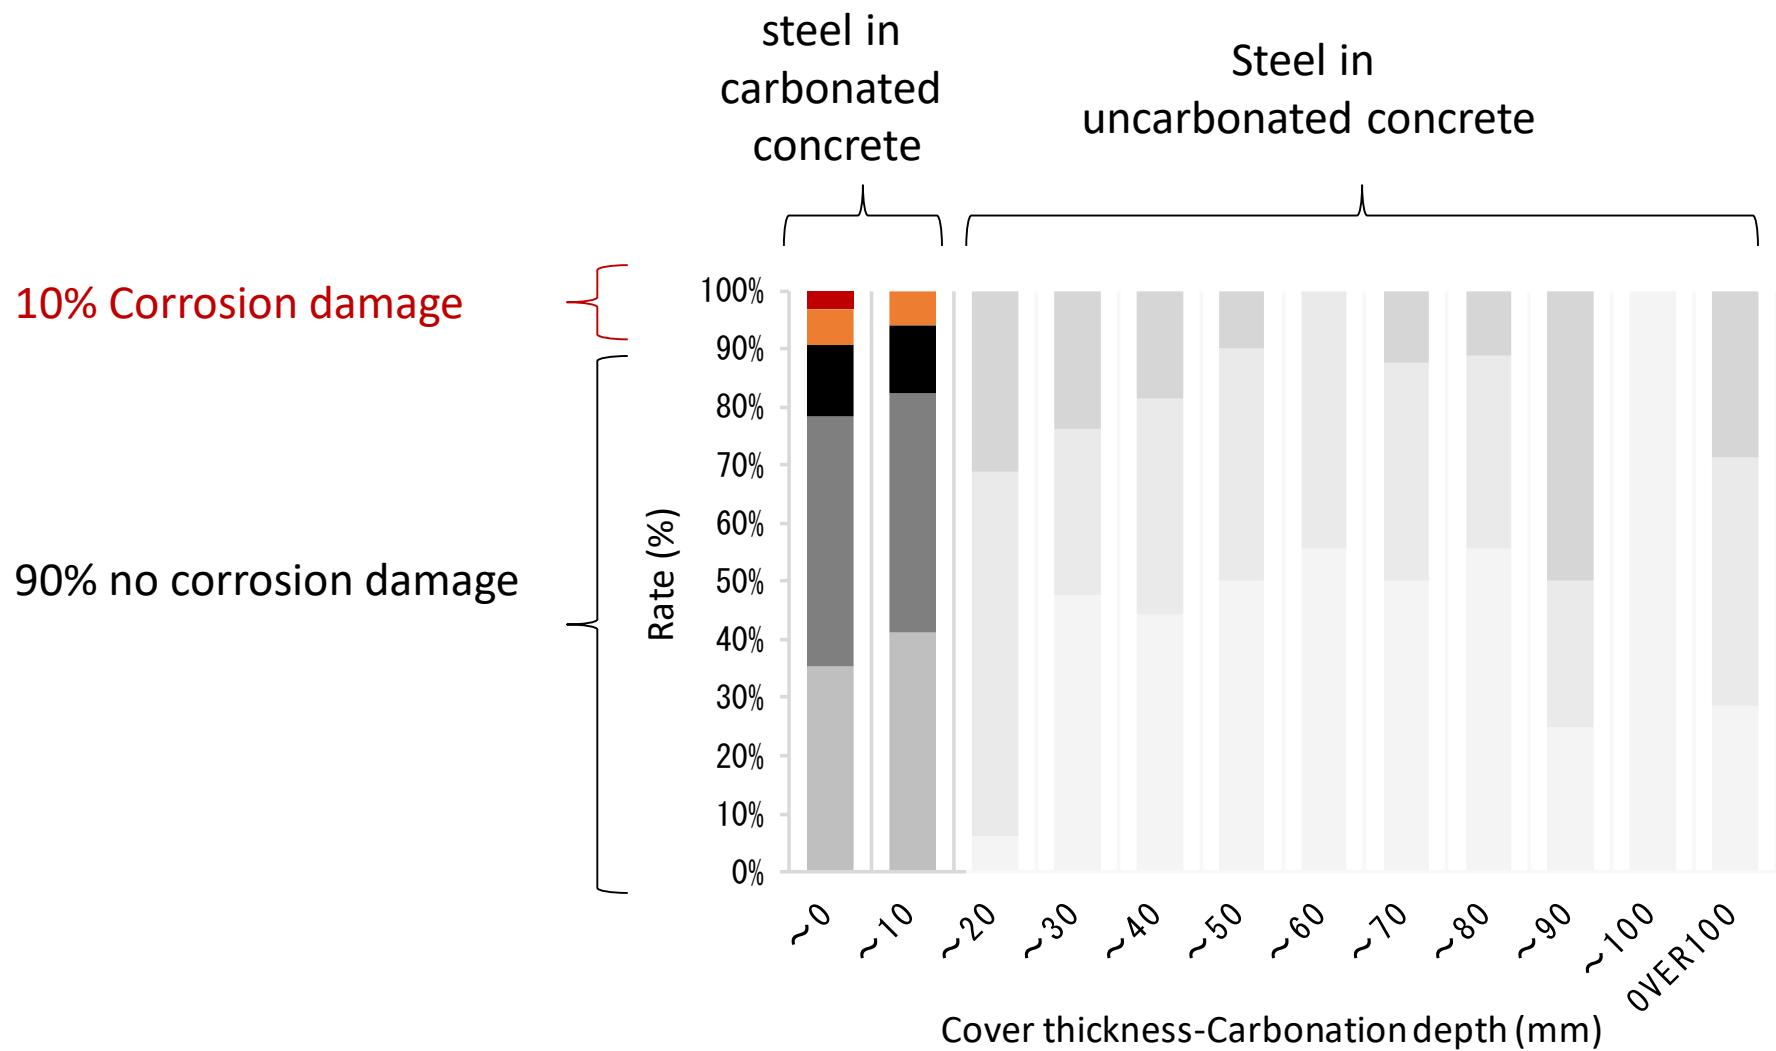
# Field evidence from 21 buildings in Japan:

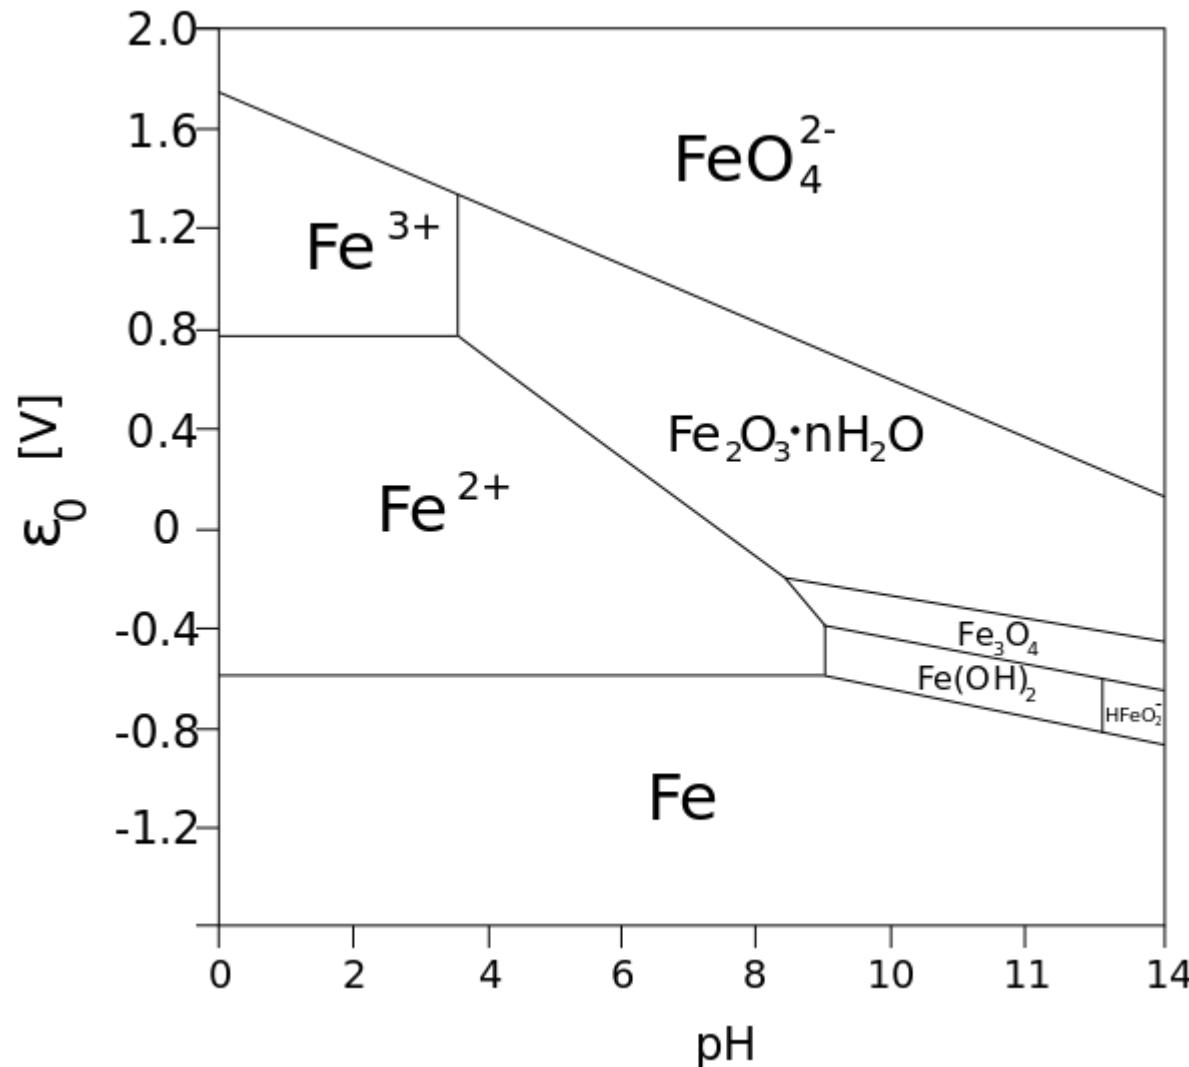
# Passivation and Depassivation Pourbaix Diagramm

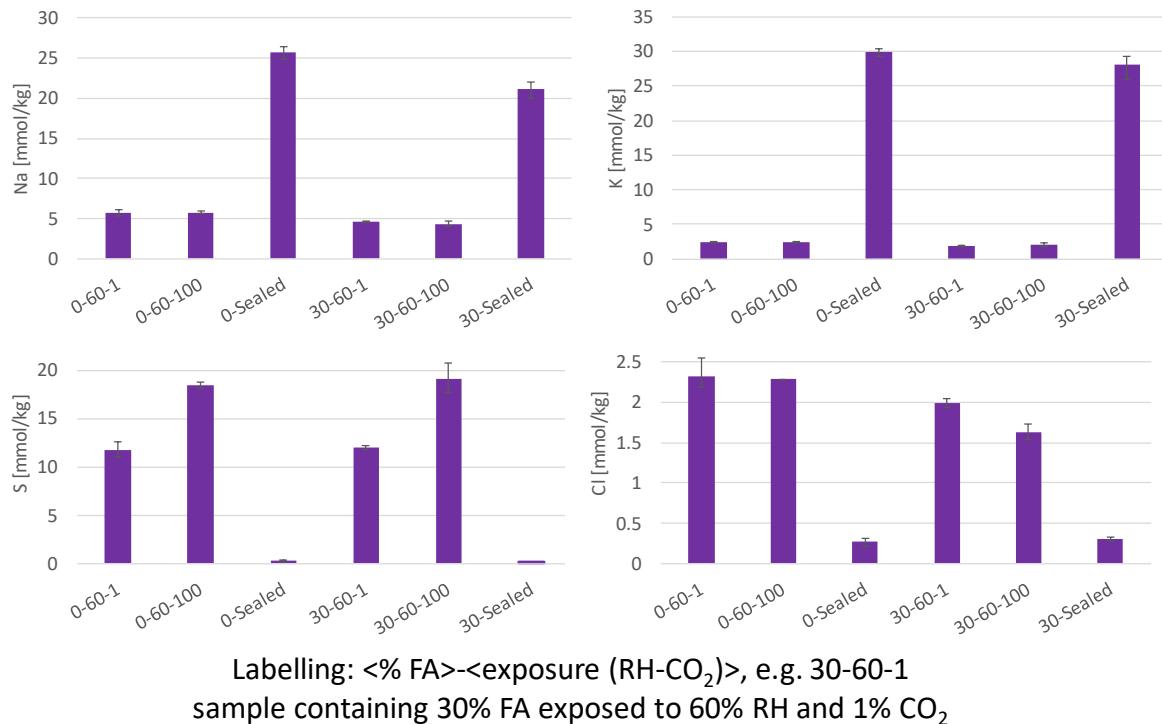
# Pore solution of carbonated mortar

Materials (w/c 0.55, 2 weeks sealed)  
CEM I (0% FA)  
CEM II/B-V (30% FA)

Exposure (for 20 weeks)  
Sealed  
20°C, 60% RH, 1% CO<sub>2</sub>  
20°C, 60% RH, 100% CO<sub>2</sub>

Methods  
pH indicator  
TGA  
Cold water extraction (CWE) + ICP

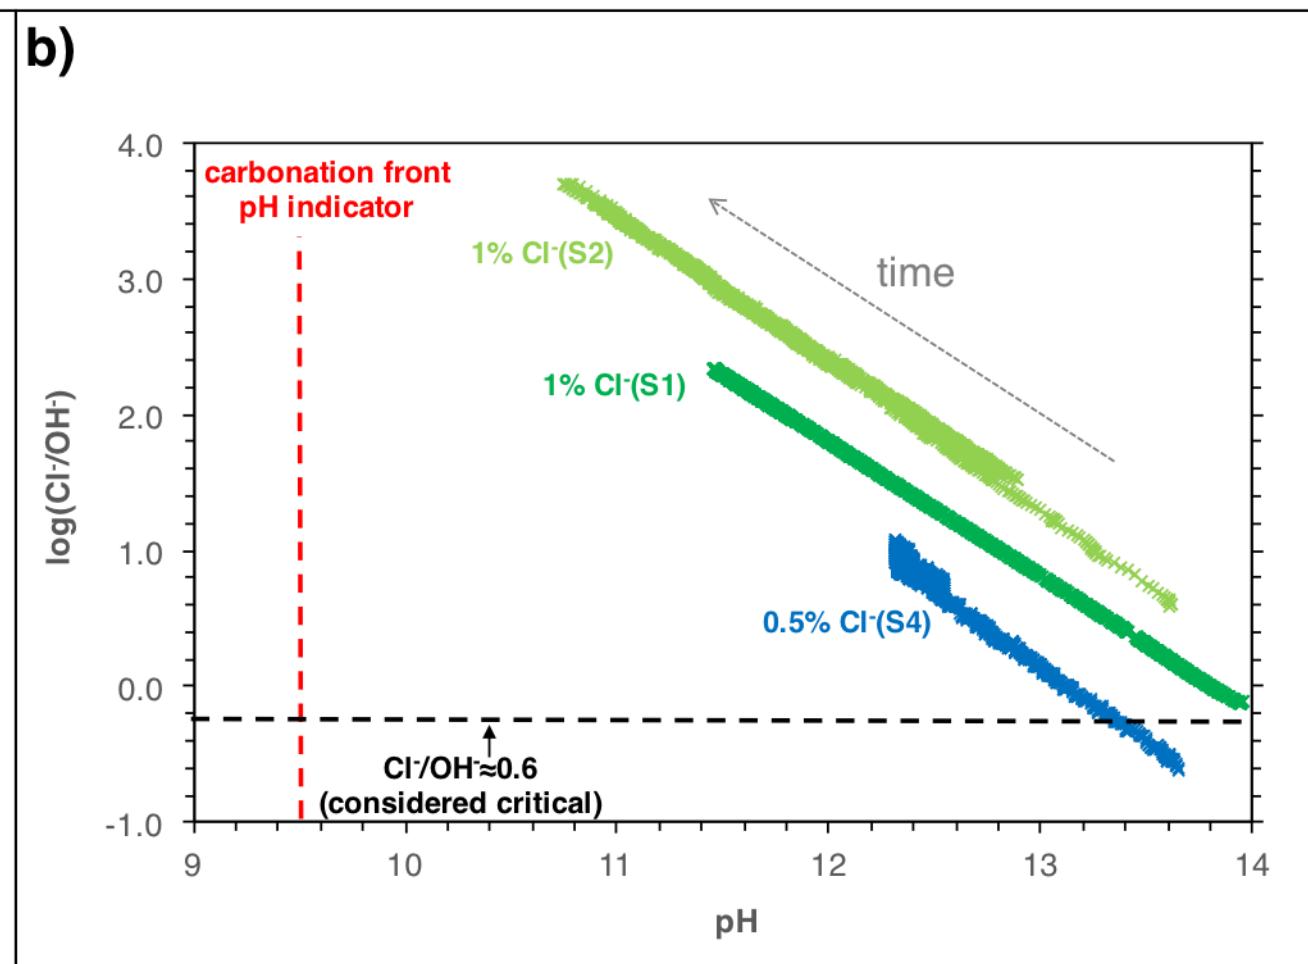
# $\text{Cl}^-/\text{OH}^-$ ratio

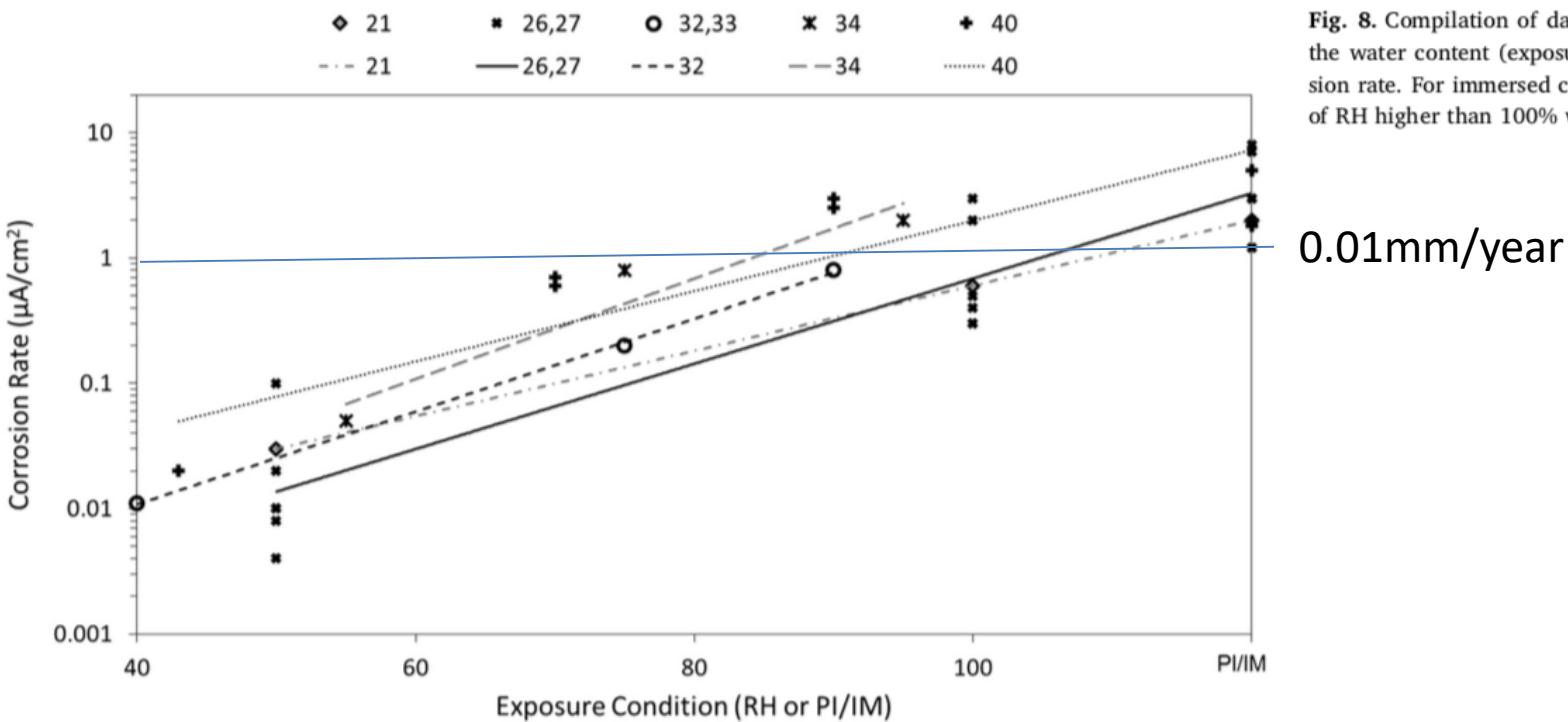
# Influence of exposure moisture condition on corrosion rate

Fig. 8. Compilation of data showing the influence of the water content (exposure condition) on the corrosion rate. For immersed conditions an arbitrary value of RH higher than 100% was chosen.

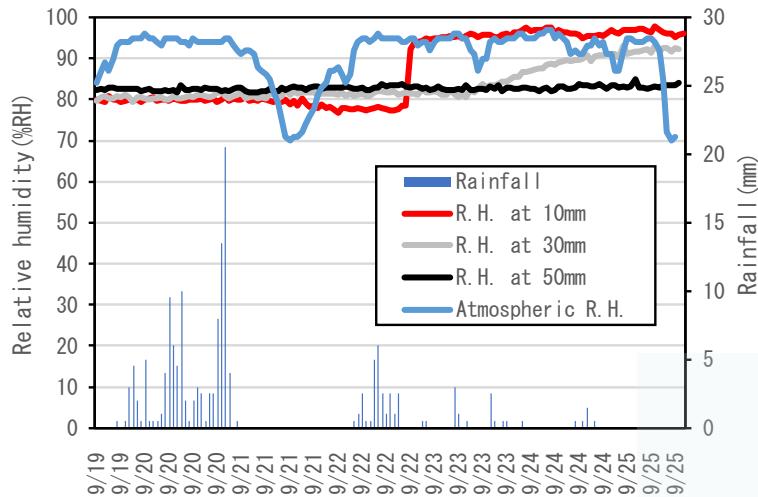
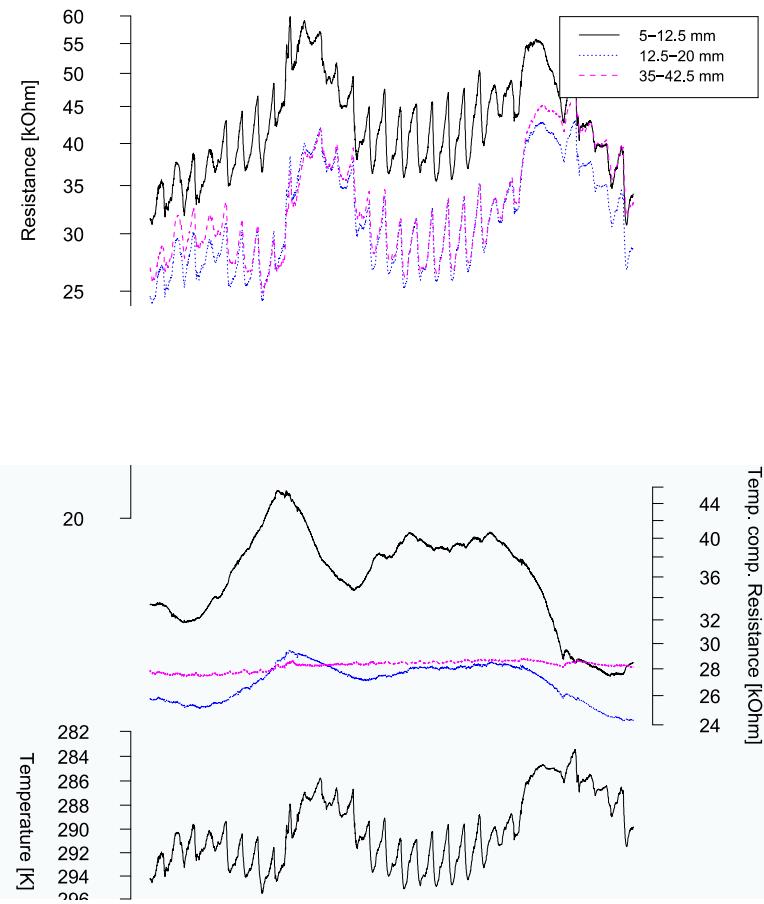
# Changes in R.H. in various cover depth
